RCM Technical Note – Critical Update 2.3.5

Critical Bug Due to SystemSettings Import File

Present in Versions 2.3.0 through 2.3.4

February 22, 2021 • r1

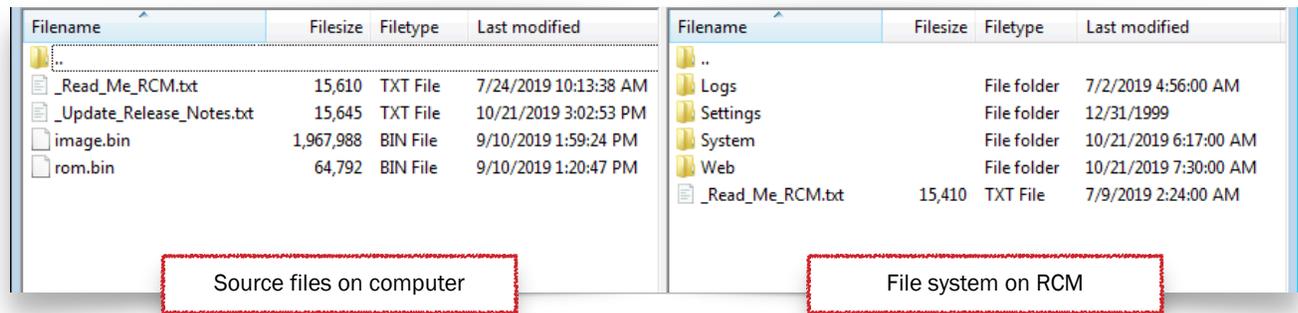
Figure 1: An example FTP window with source and destination file lists.

Most FTP applications are going to show a source and destination set of files. Navigate the source list to the files in the RCM Firmware Update folder, which should look similar to the list on the left. The list on the right is the RCM PDU file system.

With FTP connected, the new update files are ready to be transferred to the PDU. Assuming you're using a graphical program with a visual presentation similar to the above, files can be transferred as described below.
